PASSAIC RIVER BASIN  
ROCKAWAY RIVER, MORRIS COUNTY  
MORRIS COUNTY  
NEW JERSEY

ROCK RIDGE LAKE DAM

NJ 00178

PHASE 1 INSPECTION REPORT  
NATIONAL DAM SAFETY PROGRAM

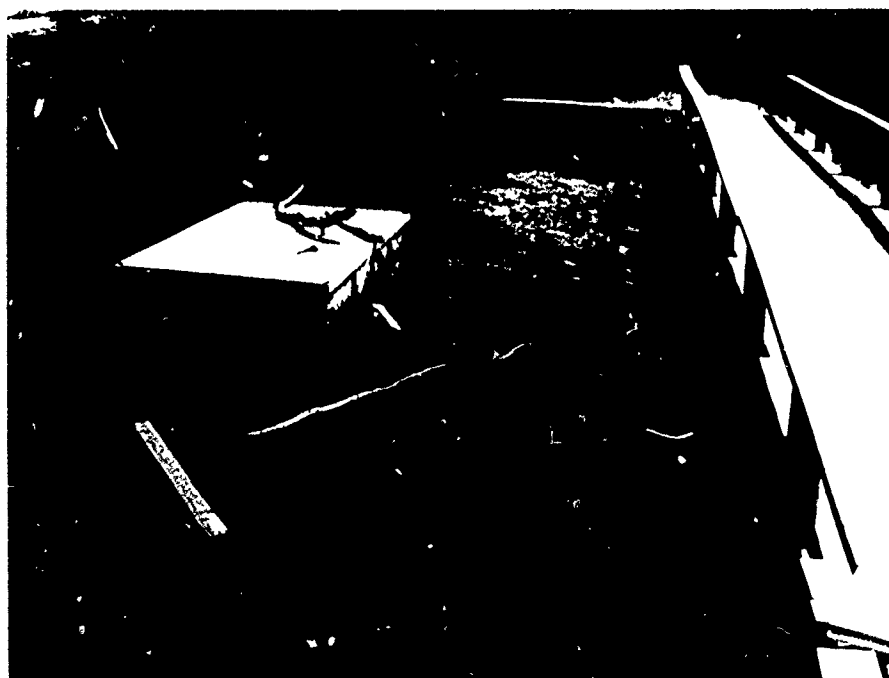
b. Appurtenant Structures. The concrete spillway apron has an open and unsealed expansion joint. Several drill holes have been made in the top surface of the concrete middle apron of the spillway. The concrete weir and training wall exhibited evidence of minor spalling and surface erosion to a maximum depth of 1 inch. The concrete spillway apron appears to have been recently extended. The 12-inch low-level outlet pipe and valve appeared to be in fair condition but were not operated during the inspection. The service bridge beams and decking were in good condition.

VIEW LOOKING NORTHEAST ACROSS SPILLWAY APRON UPSTREAM OF  
SERVICE BRIDGE

(5) Design repairs to the concrete spillway apron and areas of spalling and erosion on the weir and training wall.
